TEMPLAR KNIGHT CHRONICLES

WHY ROOFING AND WATERPROOFING SYSTEMS FAIL

**NORTHWEST
CONSULTING &
INSPECTIONS INC.**

Specializing in the Roofing and
Waterproofing Construction Trade

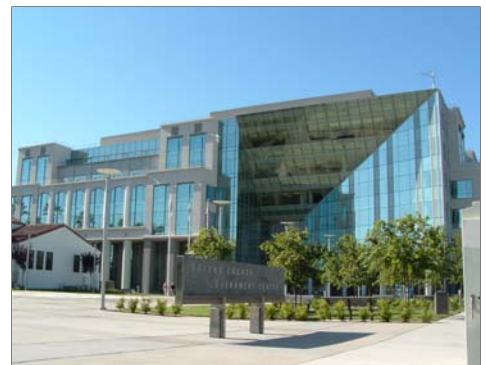
Leo Richardson, Johns Manville Taper Design Center, designed the most economical insulation system to provide maximum insulation value and positive drainage. First a one-quarter inch tapered rigid board with half-inch tapered crickets were installed with a half-inch cover board over both concrete and metal decks. Then, three plies of type VI felts with a granulated cap sheet surfacing were installed. The cap sheet was coated with Topgard® 5000 and Topgard® Base coat. This roof system also qualifies toward the TITLE 24-Energy Compliance and is Energy Star rated.

of the biggest challenges on the job was to create a positive slope to drain.

“The drainage system was the most important issue because of the size of the roof and the complexity of the inside and outside corners,” Franko with NCI said. “Fortunately Solano County Roofing had a lot of experience with creating slopes in the field and did an outstanding job.”

Solano County Government Center, Fairfield CA. Solano County officials knew what they wanted for their new government center. According to Darby Hayes, assistant county administrator and project director, the Solano County Government Center was to be designed, constructed and equipped with energy efficient and sustainable design measures, materials, and devices that were feasible, proven and cost-effective. The \$100 million project, which spans three city blocks, includes an administration center that consolidates 15 county departments, a 43,000-square-foot probation building, a five-level parking center, and a public plaza and courtyard. The configuration includes roofing and waterproofing surfaces in a variety of configurations.

The roof was seven stories high, so it was necessary to hoist materials. A crane was used to fly up the tapered insulation.

Everyone on the team was committed to a watertight roof and took additional measures to ensure the roof’s integrity. For example, large pads designed to accommodate the air-conditioning units were exposed to the elements until the units could be set. Clark Construction built temporary roofs over the air-conditioning curbs to keep the roof watertight. Pitch pockets were eliminated from the roofing system to ensure the roof’s integrity.
